Having a Come-Apart: Lessons Learned from Additively Manufactured Hardware Failures

Paul Gradl, Ben Williams, Colton Katsarelis, Gabriel Demeneghi,
Will Tilson, Brian West, David Ellis, Alison Park

National Aeronautics and Space Administration (NASA)

3 November 2022

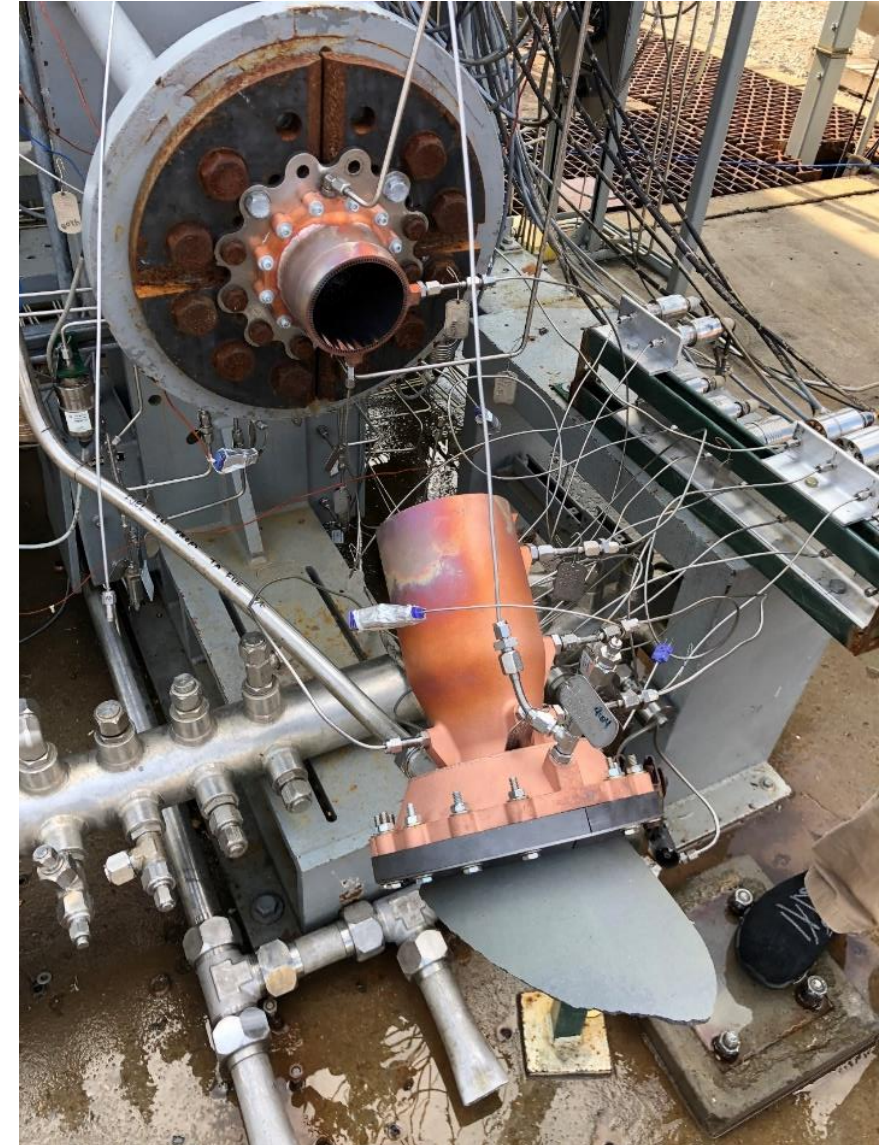
**7k-lb_f GRCop-42
chamber and
Composite Nozzle**

- Tested in early 2021
- Location: MSFC Test Stand 115
- L-PBF GRCop-42 chamber
 - 9 starts and 83.3 seconds total before separation.
 - No issues observed in prior chamber test data.
- Carbon-Composite experimental nozzle
 - Untested and possessed a noticeable crack.
 - Deemed an acceptable risk.

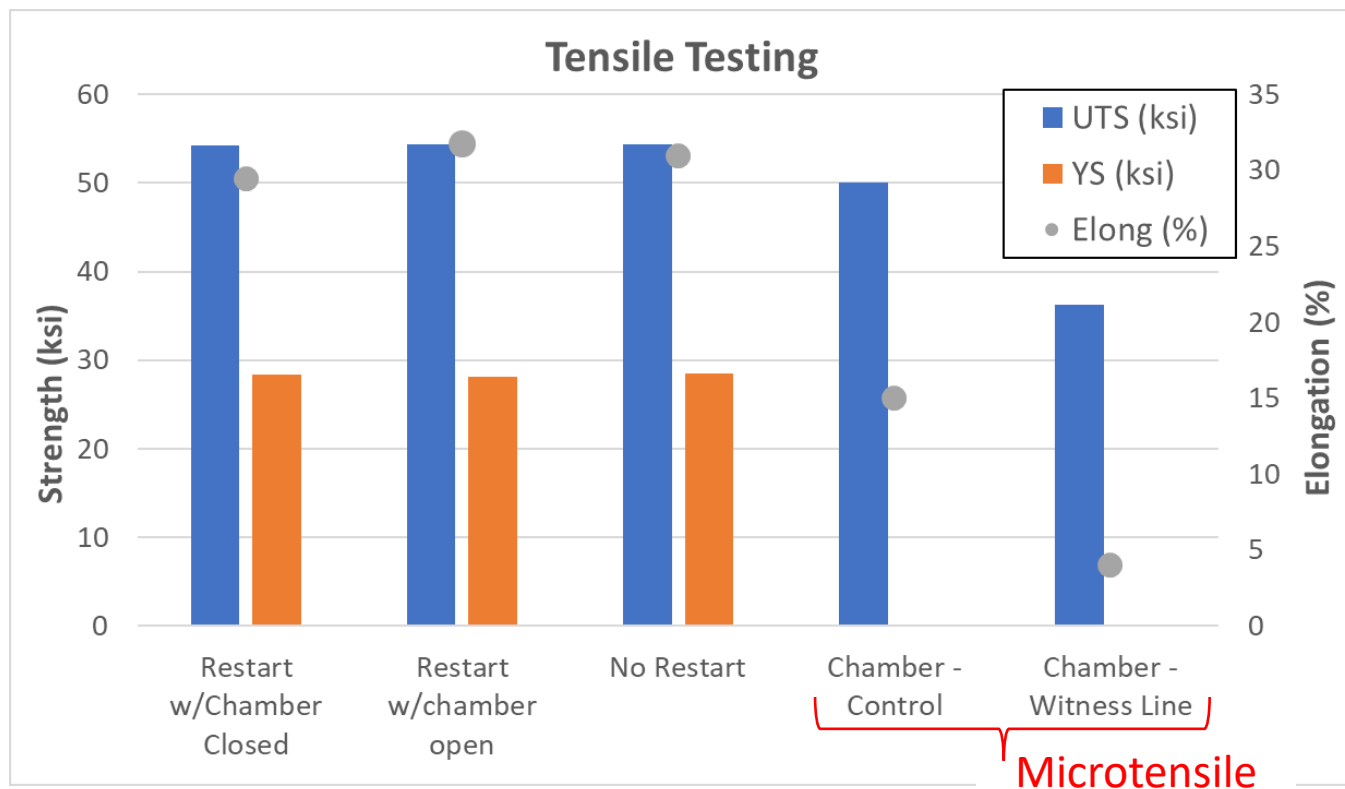
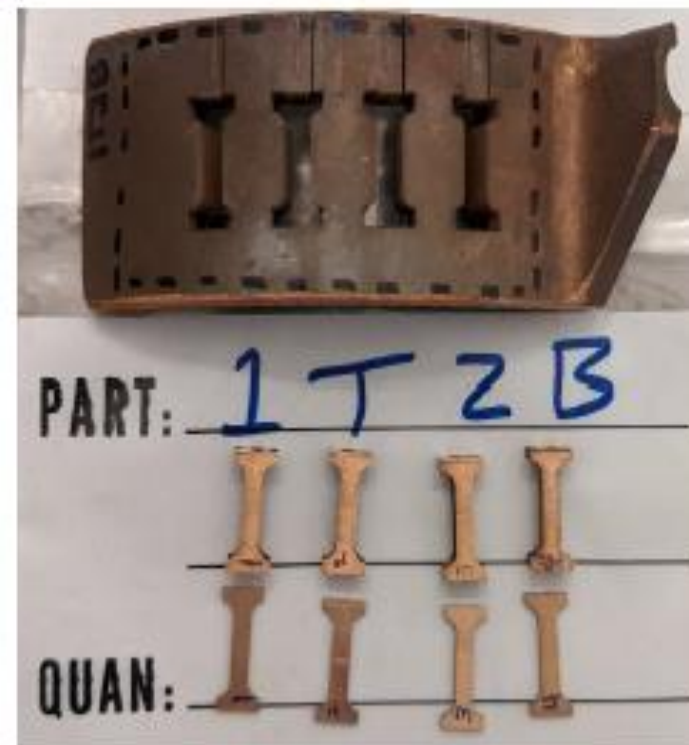
Combined Microtensile & Tensile Results

- Room temp tensile testing conducted on ASTM E8 specimens (0.25" dia gage) from witness bars with various restarts
 - Testing at 1200F for ASTM E8 round bars showed similar trends
 - Fracture surfaces appeared similar
- Microtensile testing conducted at room temp on section from chamber (C1 and C3) at witness line and non-witness

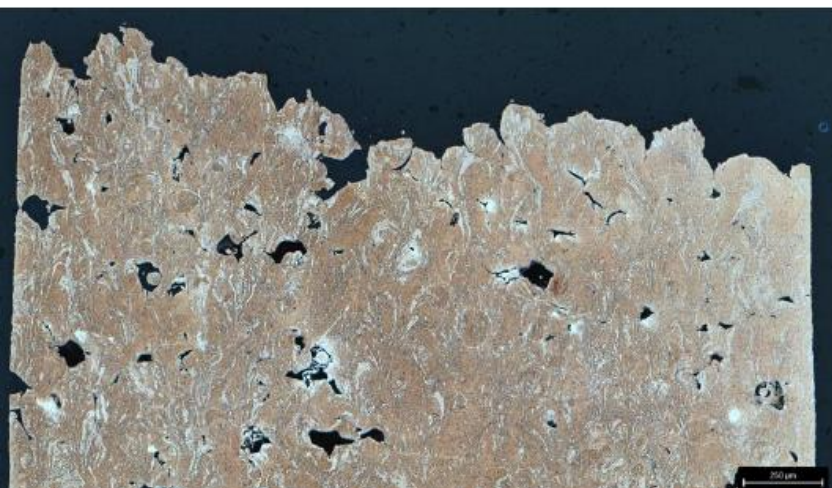
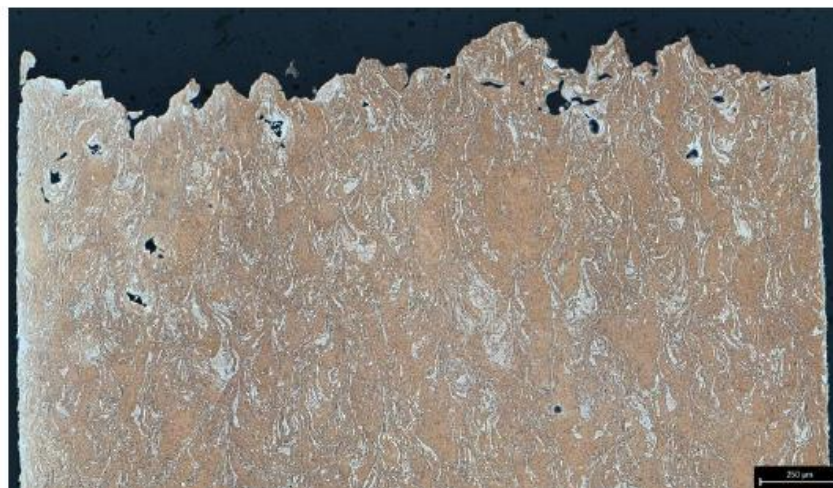
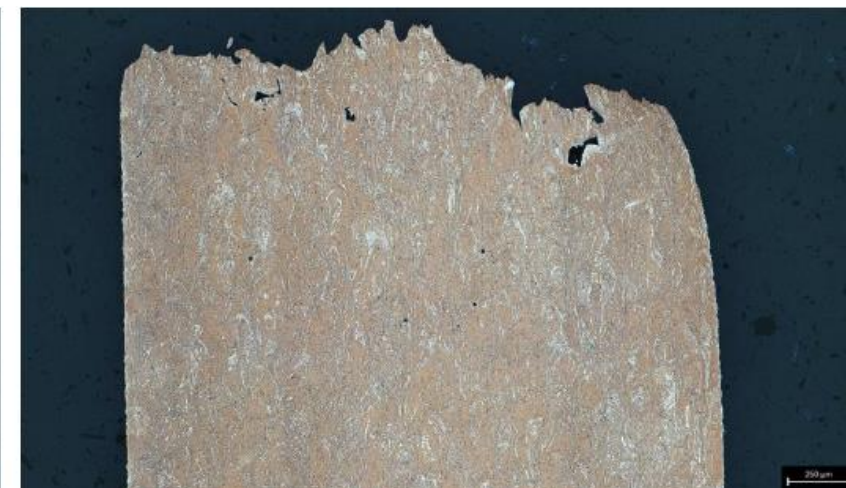
- 3 test bars from LCF
 - Fracture surfaces smeared b/c LCF had fully reversible cycles
 - Closed chamber restart bar never fully fractured
- Observations:
 - Open restart: flat surface before overload failure transition, secondary crack below primary crack
 - No restart: three separate cracks jogged together

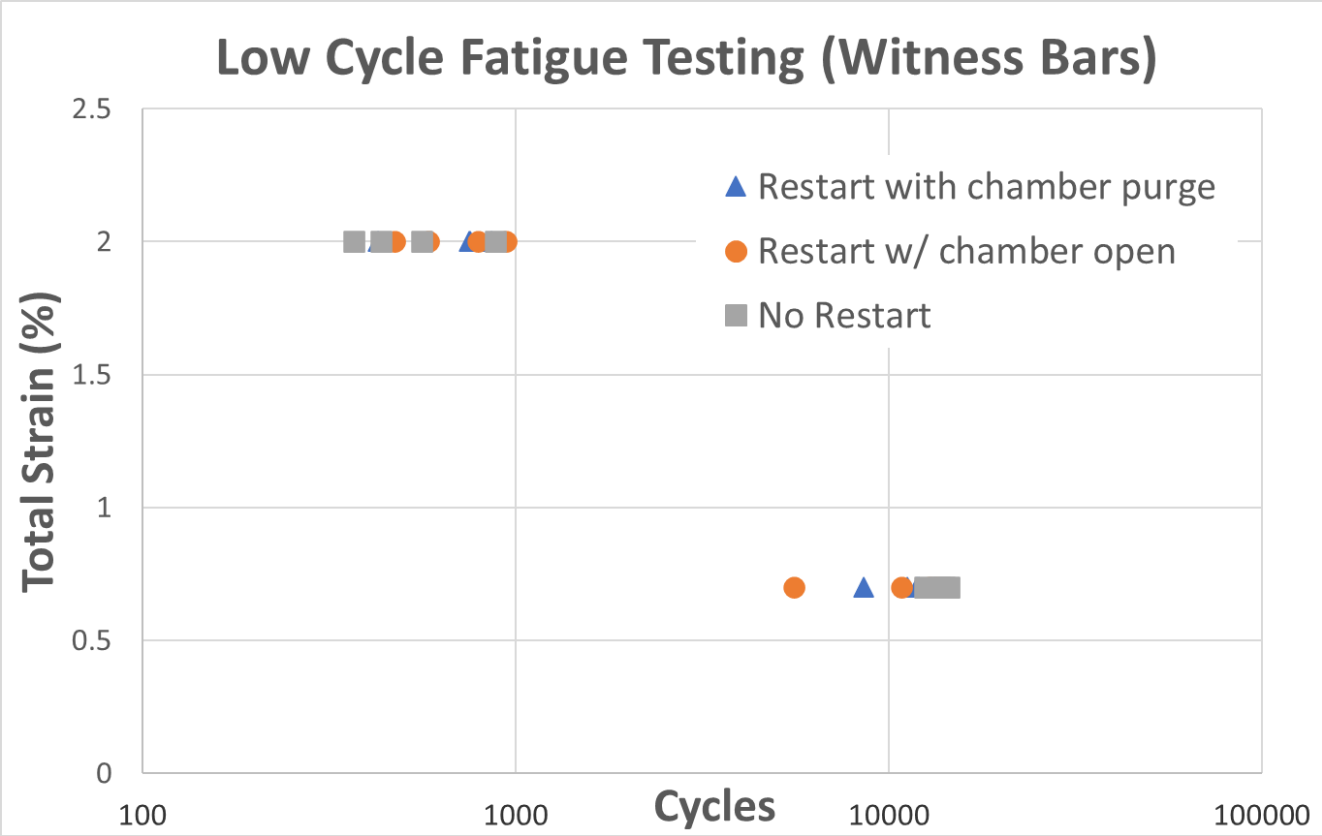
Low Cycle Fatigue of Post-build Witness Specimens

- LCF conducted at room temperature, total strain of 0.7% and 2%
- R = -1, triangular
